**REPORT TO BOARD OF DIRECTORS OF  
GENERAL MOTORS COMPANY  
REGARDING IGNITION SWITCH RECALLS**

**May 29, 2014**

Anton R. Valukas

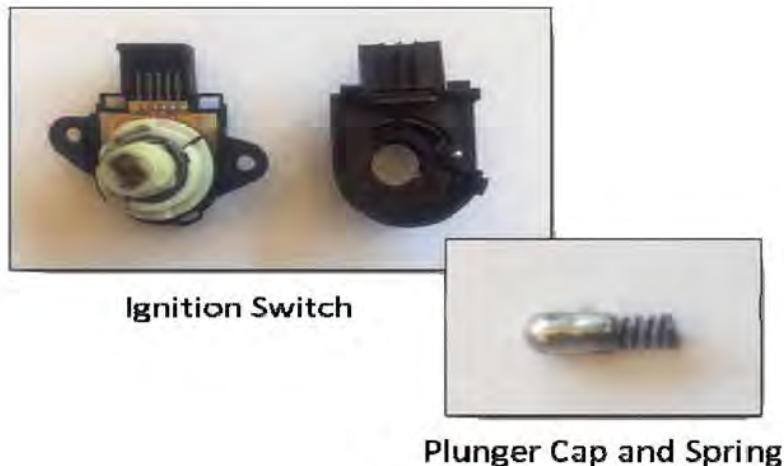
Components within the Ignition Switch control the amount of effort required to turn the switch from one position to another. A plunger cap and coiled spring inside the Ignition Switch sit in a small groove called a “detent,” which holds the switch in the position to which the driver turns the key: Off, Run, Accessory, or Crank. The driver rotates the key by applying a certain amount of torque to overcome the detent, thereby rotating the switch out of one position and into another. One method to increase the effort required to rotate the Ignition Switch from one position to another is to use a longer and more tightly coiled spring.

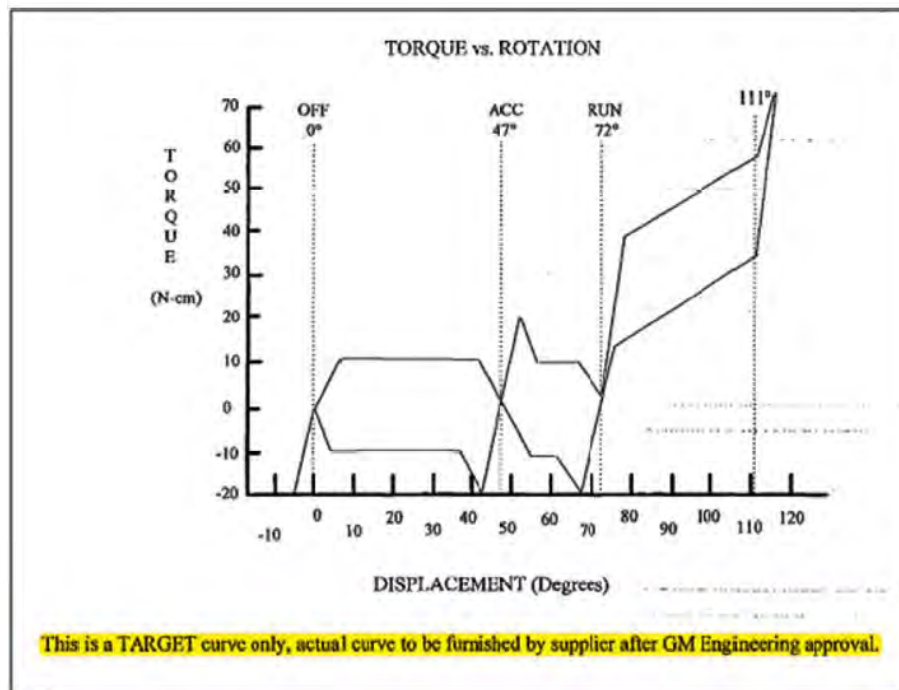
cm”) as the torque needed to turn the ignition from Run to Accessory.<sup>110</sup> As noted below, the target curve indicated that the “actual curve [was] to be furnished by [the] supplier after GM Engineering approval.”<sup>111</sup>

Section 3.2.2.3 described the desired feel of the switch – “smooth, with clearly defined detents” – and also provided that “[f]inal switch tactile feel is subject to GM Engineering approval.”<sup>112</sup> The Specification was revised in 1998 and 1999, without changes to the parameters for the torque required to rotate from Run to Accessory.<sup>113</sup>

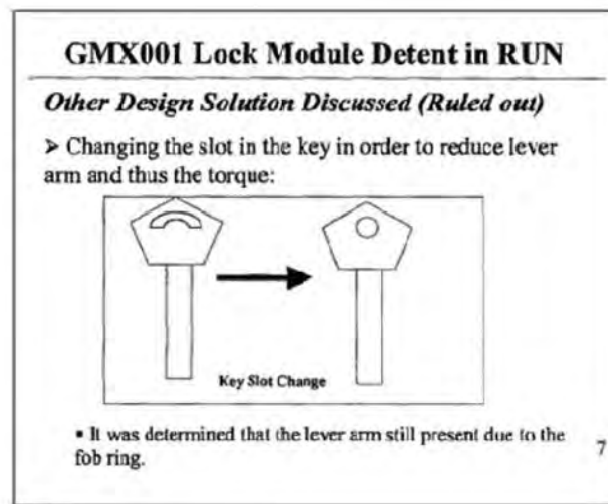
The presentation also included some “Ruled Out” solutions, including changing the design of the key head from a slot to a hole – a solution GM personnel ultimately pursued. With a slot design, the key ring could move up and down in the slot. If the key ring contained extra weight, that movement could exert torque on the Ignition Switch and, combined with other circumstances, move it from Run to Accessory. Keeping the key ring in the center of the key (through a hole design) would prevent such movements.<sup>261</sup> The estimated cost to make the key change was \$70,000 for tooling for a new key head, \$400,000 to modify production assembly equipment, and a piece price increase of \$0.50 per vehicle.<sup>262</sup>

The presentation to the CPIT also described a “Sure Solution” to fix the problem: change the location of the Ignition Switch on the steering column from a low-mount to a higher mount.<sup>263</sup> According to David Trush, the Lead Design Engineer on the ignition cylinder, the

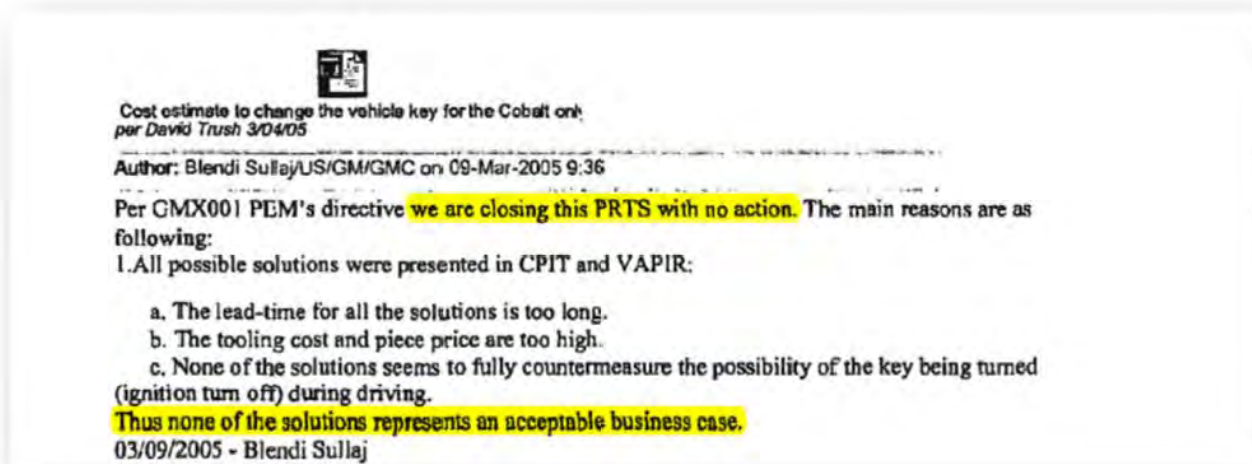
As shown above, the November 19, 2004 PRTS stated that “none of the solutions represents an acceptable business case” – a standard phrase used by GM personnel for closing a PRTS without action.<sup>271</sup> David Trush, the lead engineer on the ignition cylinder, explained that to present an “acceptable business case,” a solution should solve the issue, be cost effective, and have an acceptable lead time to implement the change.<sup>272</sup> In this case, according to Trush, the proposed changes were not implemented because none of them was guaranteed to resolve the problem completely.<sup>273</sup> Lori Queen confirmed that a discretionary, or non-safety related, part change had to clear a series of financial hurdles before it would be approved.<sup>274</sup> Engineers who proposed a discretionary change had to make out an “acceptable business case” before the

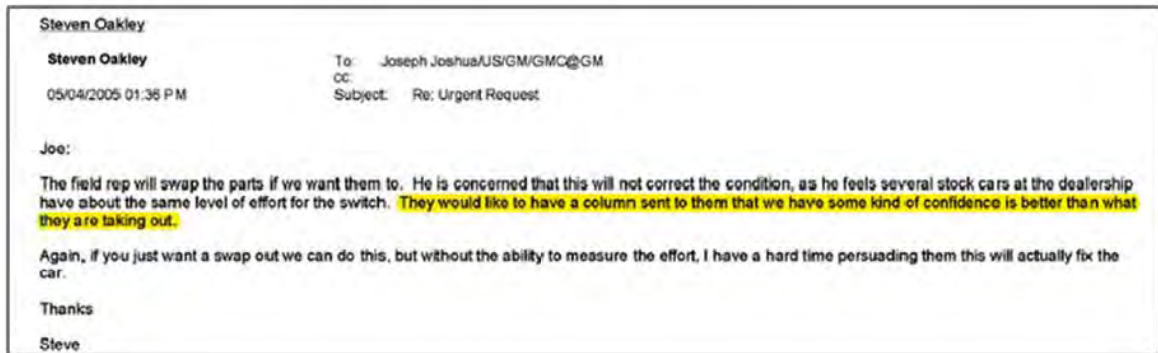
The field rep will swap the parts if we want them to. He is concerned that this will not correct the condition, as he feels several stock cars at the dealership have about the same level of effort for the switch. They would like to have a column sent to them that we have some kind of confidence is better than what they are taking out. Again, if you just want a swap out we can do this, but without the ability to measure the effort, I have a hard time persuading them this will actually fix the car.<sup>311</sup>

DeGiorgio was one of the GM personnel who received this e-mail chain, which effectively stated that the customer’s car, as well as others at the dealership, had Ignition Switches with insufficient torque and, at least in the customer’s situation, appeared to cause the car to shut off while driving.<sup>312</sup> For his part, DeGiorgio claims not to recall the e-mail exchange. DeGiorgio also claims that at this time he still had not received any complaints about the Ignition Switch in the Ion, which had the same Ignition Switch and had been in production since MY

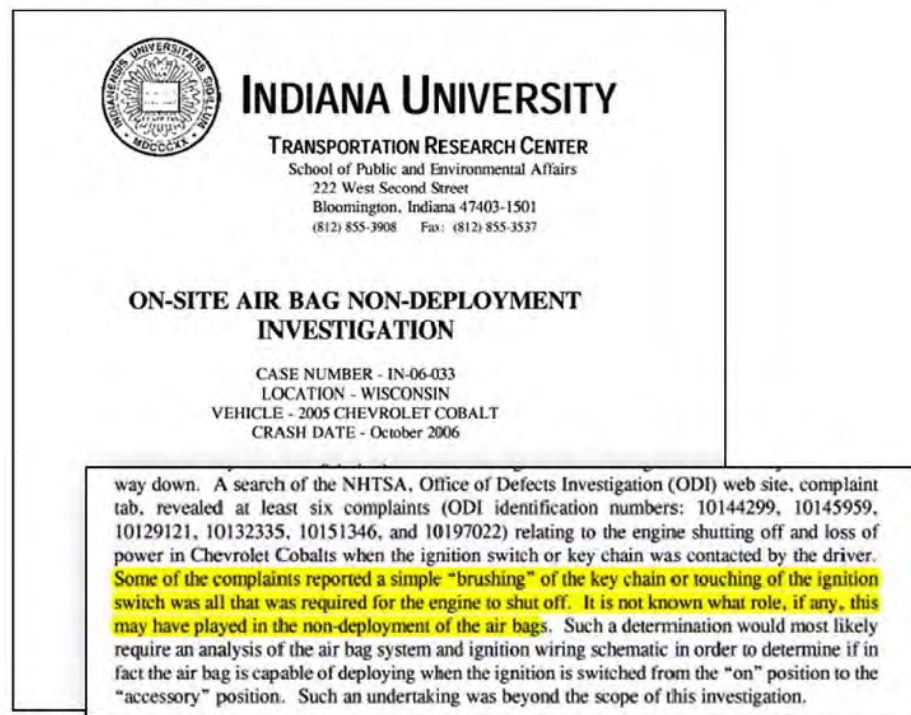
Some of the complaints reported a simple “brushing” of the key chain or touching of the ignition switch was all that was required for the engine to shut off.<sup>519</sup> The researchers concluded:

It is not known what role, if any, this may have played in the non-deployment of the air bags. Such a determination would most likely require an analysis of the air bag system and ignition wiring schematic in order to determine if in fact the air bag is capable of deploying when the ignition is switched from the ‘on’ position to the ‘accessory’ position.<sup>520</sup>
