Aircraft Accident Investigation Bureau

Aircraft Accident Investigation Preliminary Report

B737-8 (MAX) Registered ET-AVJ

Report No. AI-01/19

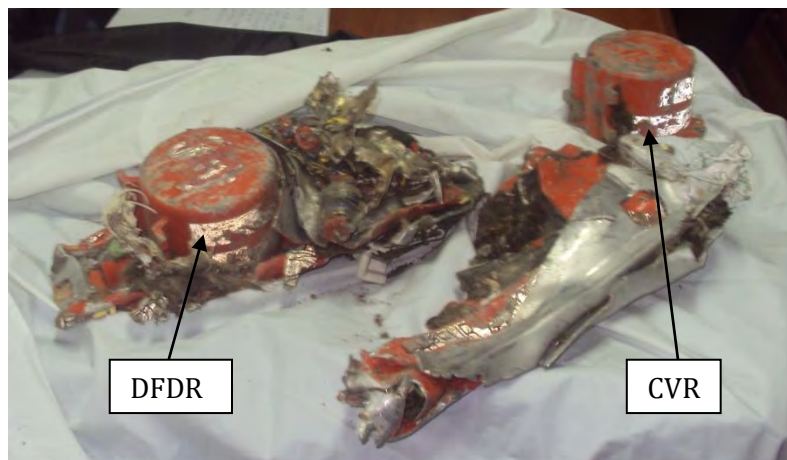
DFDR and CVR as discovered on the accident site.

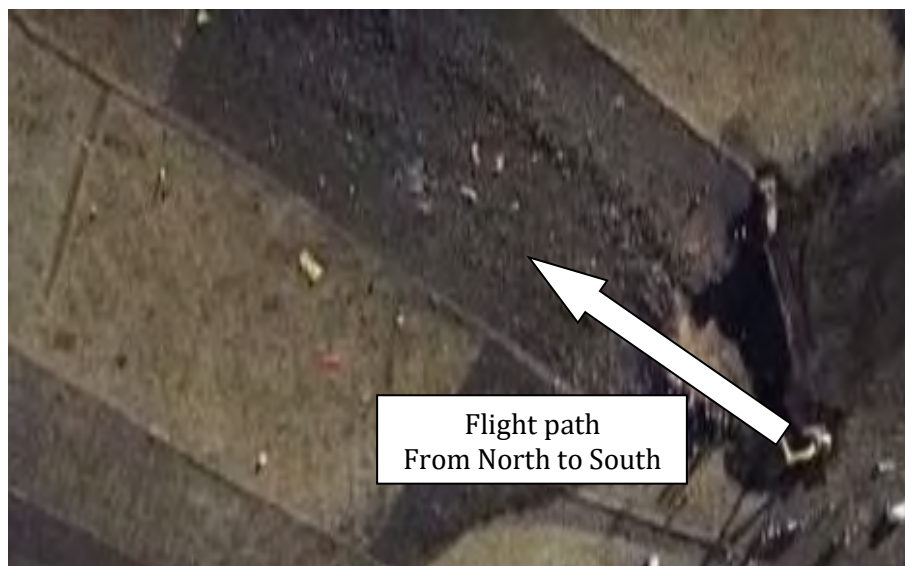
The Aircraft impacted in a farm field and created a crater approximately 10 meters deep (last aircraft part found) with a hole of about 28 meters width and 40 meters length. Most of the wreckage was found buried in the ground; small fragments of the aircraft were found scattered around the site in an area by about 200 meters width and 300 meters long.

The damages to the aircraft are consistent with a high energy impact.

Top view of the crater

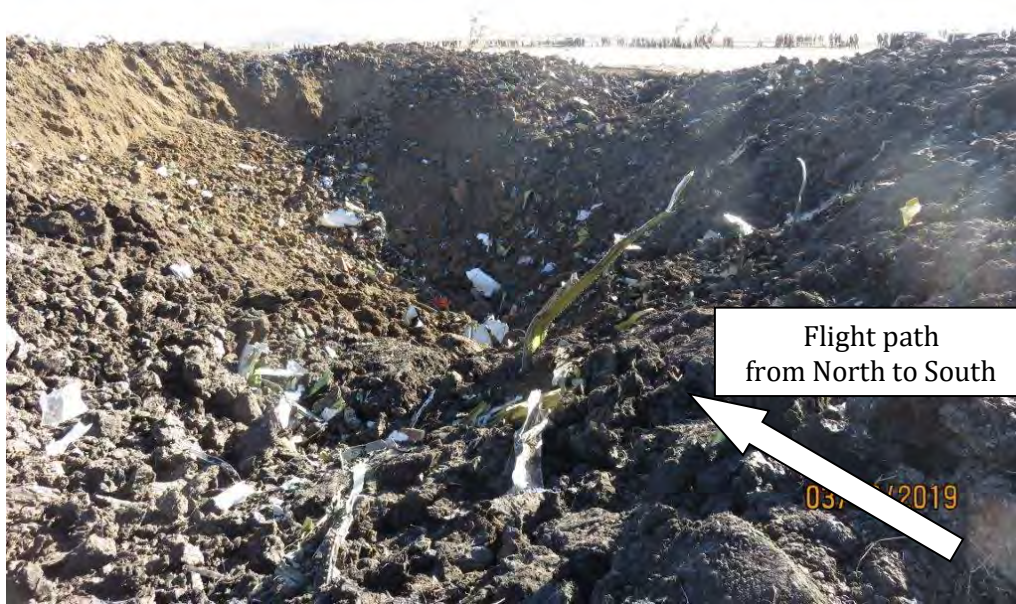
Close view of the crater before excavation
