## 2005 Chevrolet Cobalt L4-2.2L VIN F

Bulletin No.: 06-02-35-004

Date: February 02, 2006

Ignition Key Stuck (Replace Shifter Assembly or Ignition Lock Cylinder Assembly)

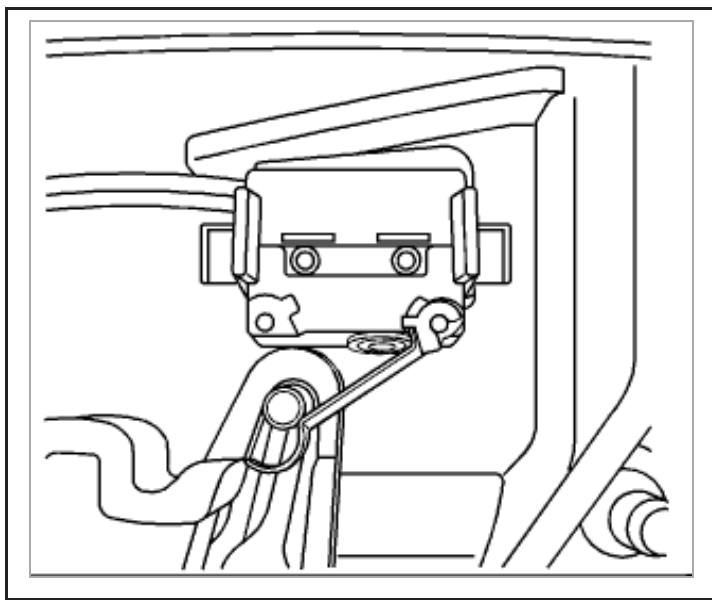
Cause 1

The pin that activates the micro-switch may have moved out of position (refer to illustration above). This causes the micro-switch to fail to engage when the vehicle is placed in Park.

Replace the shifter assembly.
